Addressing Arizona's Failing Private Water Systems

Riley Engineering, LLC

Chris Horstman, M.S., Gwen Woods, Ph.D., P.E., and
Ronson R. Chee, Ph.D., P.E.

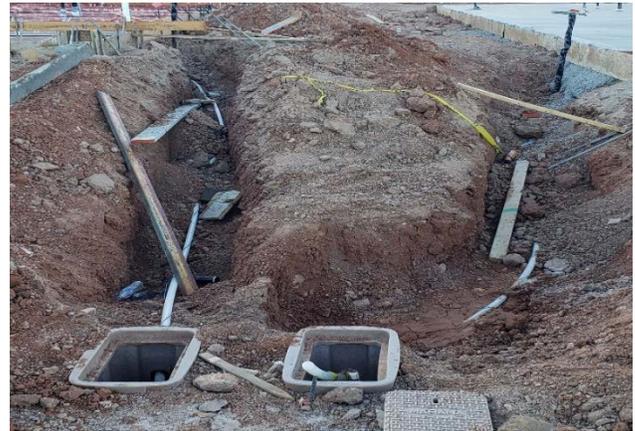
Common incorrect practice of improper materials being left in a trench before backfilling

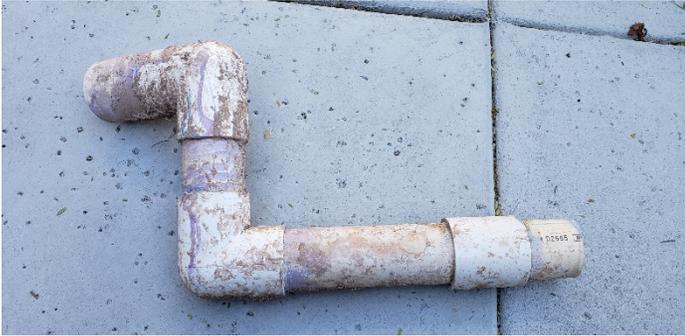
Failed supply pipe due to improper use of glued joints

While this is by no means a complete list, these are the most common causes of failure experienced by HOA communities built during the construction boom of the early 1980s. The photo shown above was taken during an assessment of an HOA water system that was repeatedly experiencing pipe bursts. This section of pipe was recently repaired, and the failure was not due to the age of the pipe. In this case, the rigidity of using glued joints resulted in premature failure of the pipe, illustrating the importance of understanding the forces acting upon a large private system and specifying the correct installation methods.

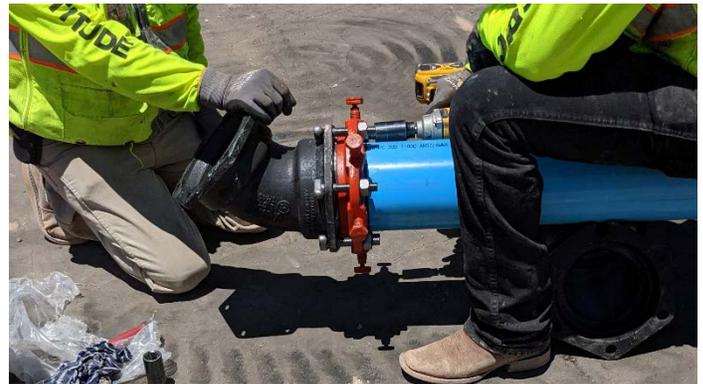
Installation of proper fittings for a PVC water main connection

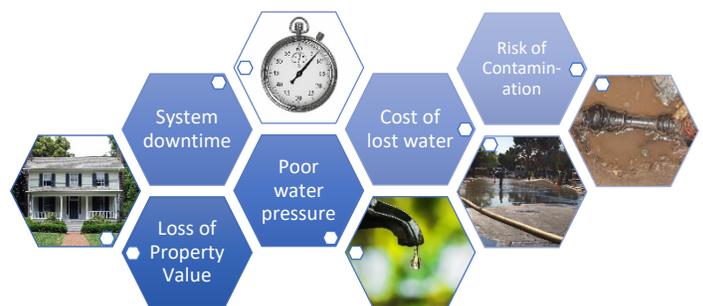
Indirect costs of failures in CWSs

When considering the question of repair or replacement, HOAs should consider not only the direct costs of repair or replacement but the indirect costs over the long term such as water cost of leaks and breaks, inconvenience to residents, and health risks from contamination that can occur when the system loses pressure (EPA, 2001). Enlisting the expertise of an experienced water engineer can help community water system owners make informed decisions and provide recommendations on the course of action that best suits the unique needs of each community.
